Case Study 3

Biological remediation in the Ross River Dam spillway

Townsville City Council – Disaster Recovery, Biological Remediation and Catchment Priming using Probiotic Formulations. Ross River Spillway Event, February 2019.¹⁷⁷

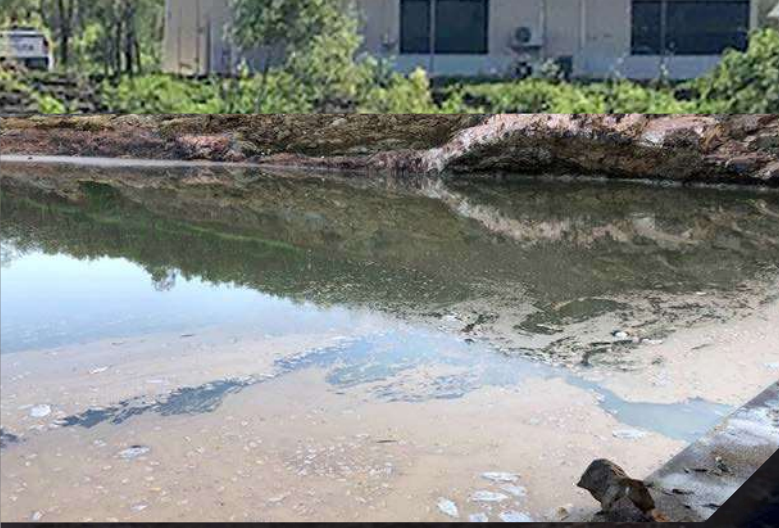
Day
3

Progressive treatment of the spillage basin beneath the Ross River Dam wall began with the sprayed application of a probiotic agent on the near-solid mass of dead tilapia (background photo, day 1); within three weeks the decontaminated water could be released downstream.

Over a four-week period, the various organisations were able to administer a combination of biological treatments to manage odours, accelerate biological decomposition of the fish, reduce risks of spreading noxious fish, significantly reduce clean-up costs, improve water quality prior to release of water downstream and ultimately convert approximately 100 tonnes of putrefying noxious fish into a positive environmental outcome.
